USACERL Special Report 96/19
December 1995

The Barksdale Air Force Base Historic District

Project Overview, History, and Maintenance Plan

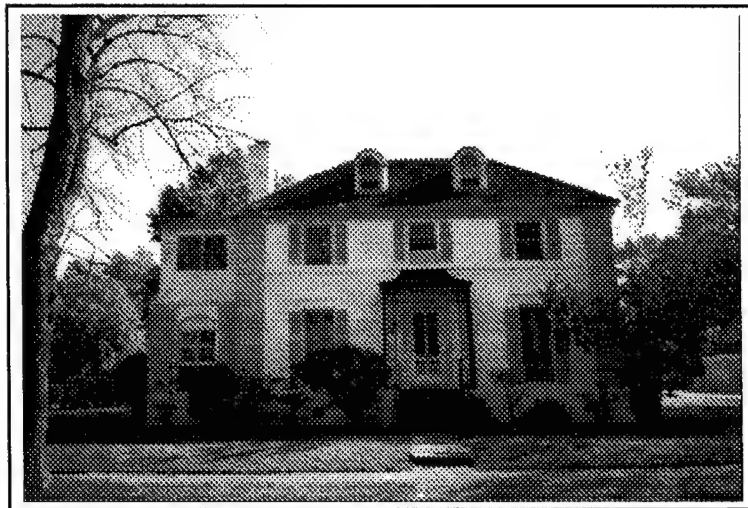
The Company Officer Quarters Type A single family houses were designed in the French Colonial Revival style. They are located throughout the officer housing area, and they are typically arranged in pairs, sometimes framing other buildings. Constructed of terra-cotta block bearing walls on a concrete foundation, the houses contain two stories, an attic, and a crawl space. The main mass of the buildings consists of an L-shaped two-story block with an additional one-story wing on the rear. The building facades are symmetrical except for the two-story porch wing set back on either the left or right side. Both levels of the side porch wing are now enclosed. An open entry porch projects from the center of the front facade.

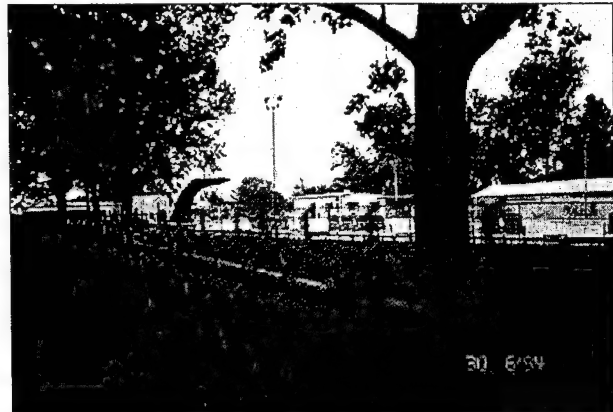
Front Elevation

This structure was completed in 1938 and basically is in it's original state, but does not contribute to the visual make-up of the historic district.

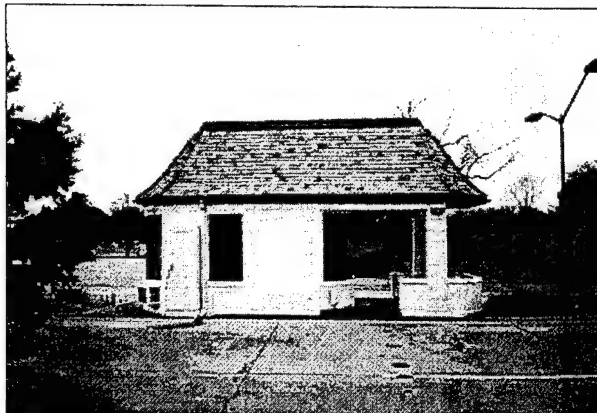
Front Elevation

This structure was completed in 1935 and presently serves its original function. It has undergone many alterations which have compromised the structure's historic integrity. The gates have been completely removed. An additional porch was created changing the proportions of the original structure. A window was filled in, and remaining windows have been changed from wood multi-light fixed windows to non-compatible brown anodized aluminum single light fixed windows. Also a single light door of non-compatible brown anodized aluminum was added into the window arrangement on the rear of the guard house.
